Jekyll Island marsh fragments: Assessing ecological function and health for restoration planning

Study Objectives

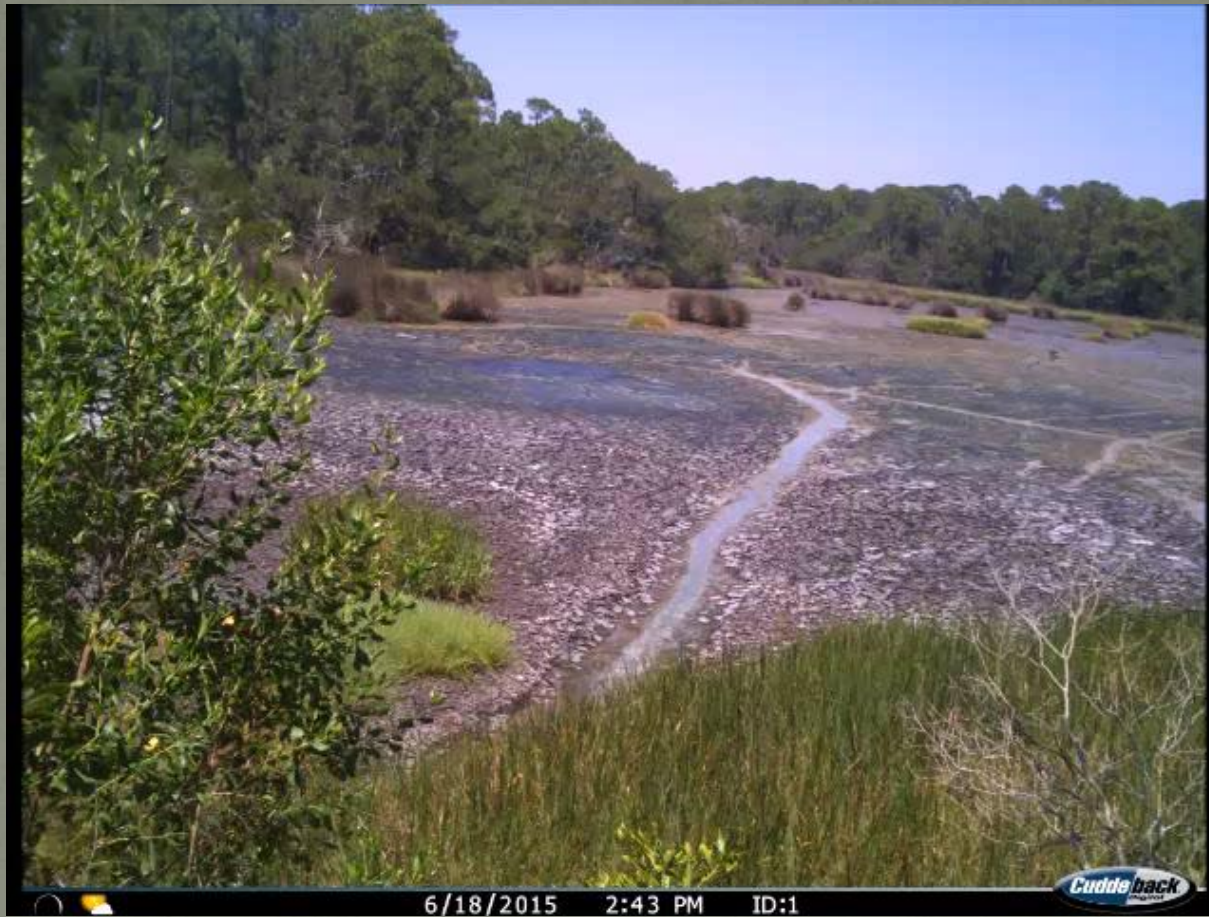
Fortson Pond Time Lapse

AM High		PM High	
	Time	Height	Time	Height
6/18/2015	11:02	6.5	23:23	7.6
6/19/2015	11:48	6.3		
6/20/2015	12:05	7.3	0:33	6.2
6/21/2015	12:46	6.9	1:16	6.1

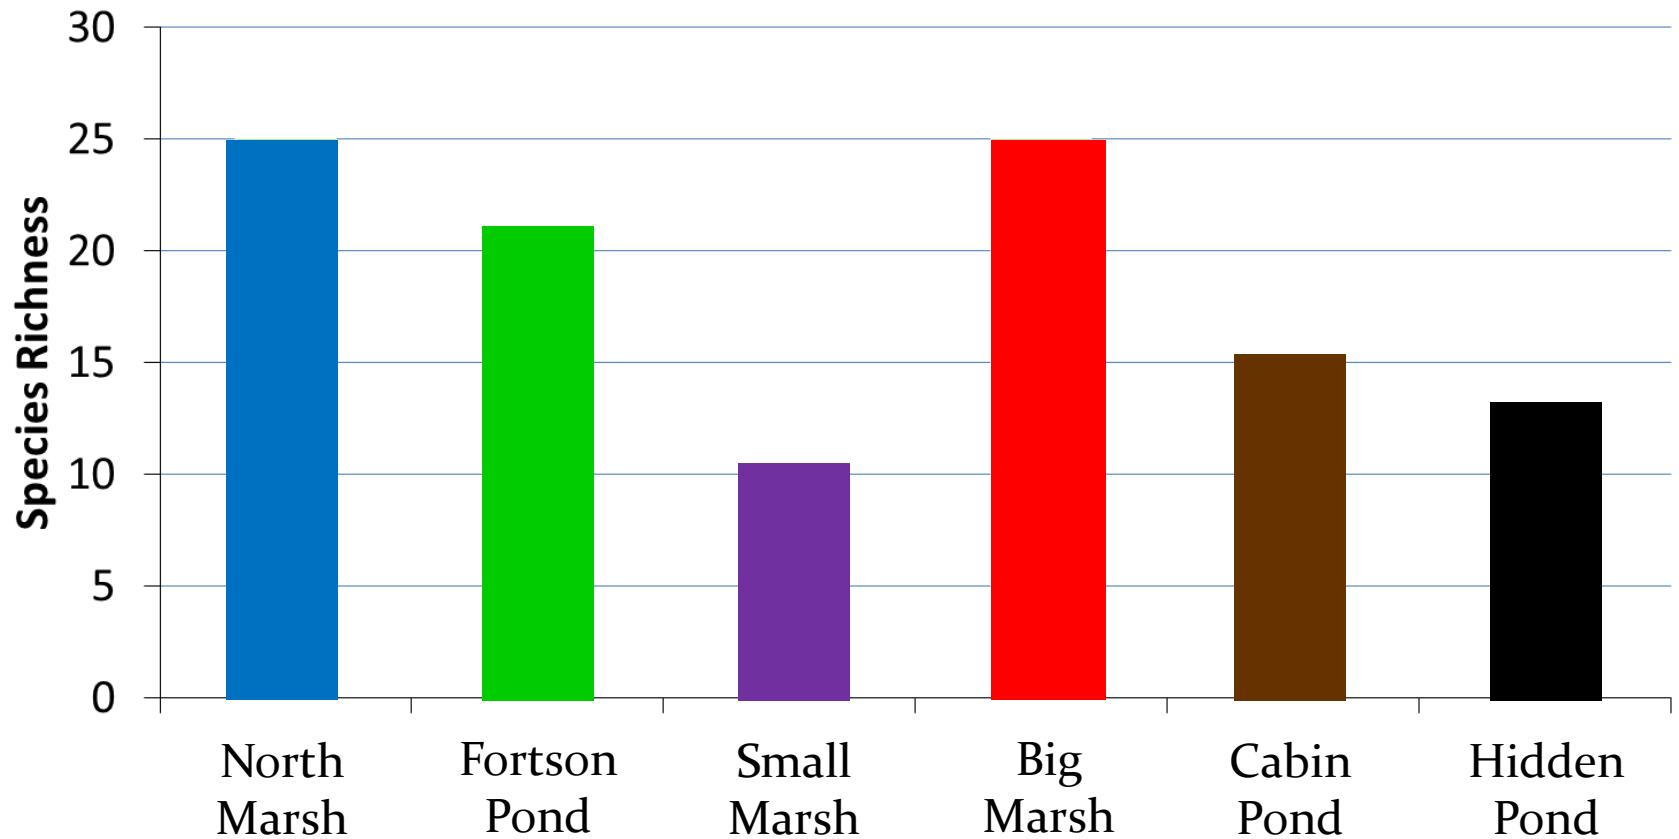
Species Richness across all marsh and reference sites. Our initial assumption that Fortson Pond offered little utility for wildlife may have been incorrect in relation to neighboring marshes. This finding does not however lead us to conclude that Fortson pond's utility for wildlife is at its full potential.

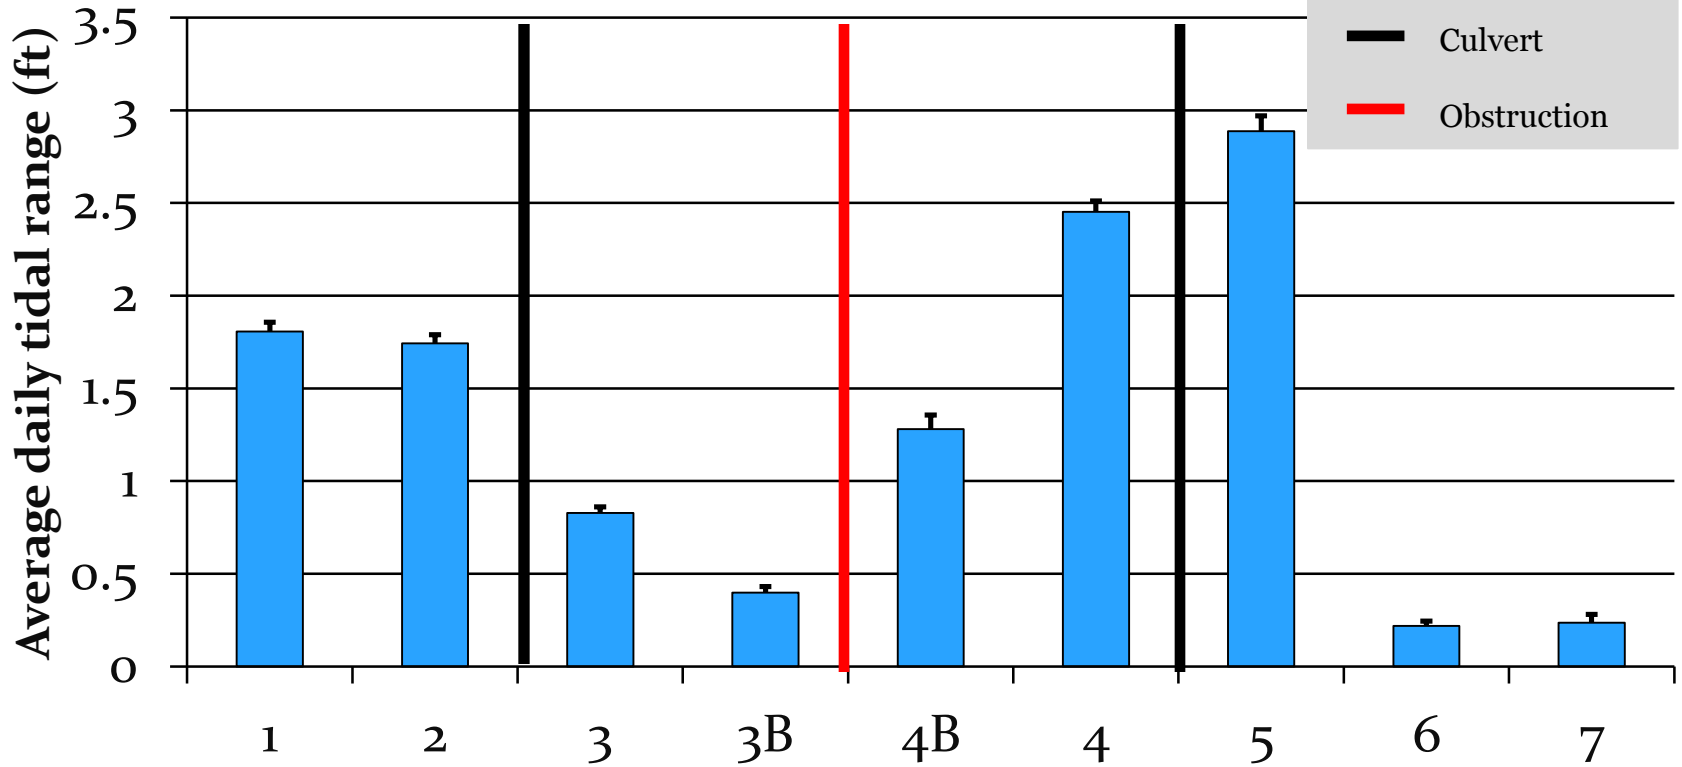
Average Daily Tidal Range

Average daily tidal range: Water-level logger sites 1 to 5 are arranged sequentially from North to South through the system, showing that tidal range is most restricted in the middle of the sequence, at the southern end of Fortson Pond (site 3B). “Cabin” and “Hidden” ponds (site 6 and 7) have lower tidal range than Fortson Pond. Error bars are 95% C.I.

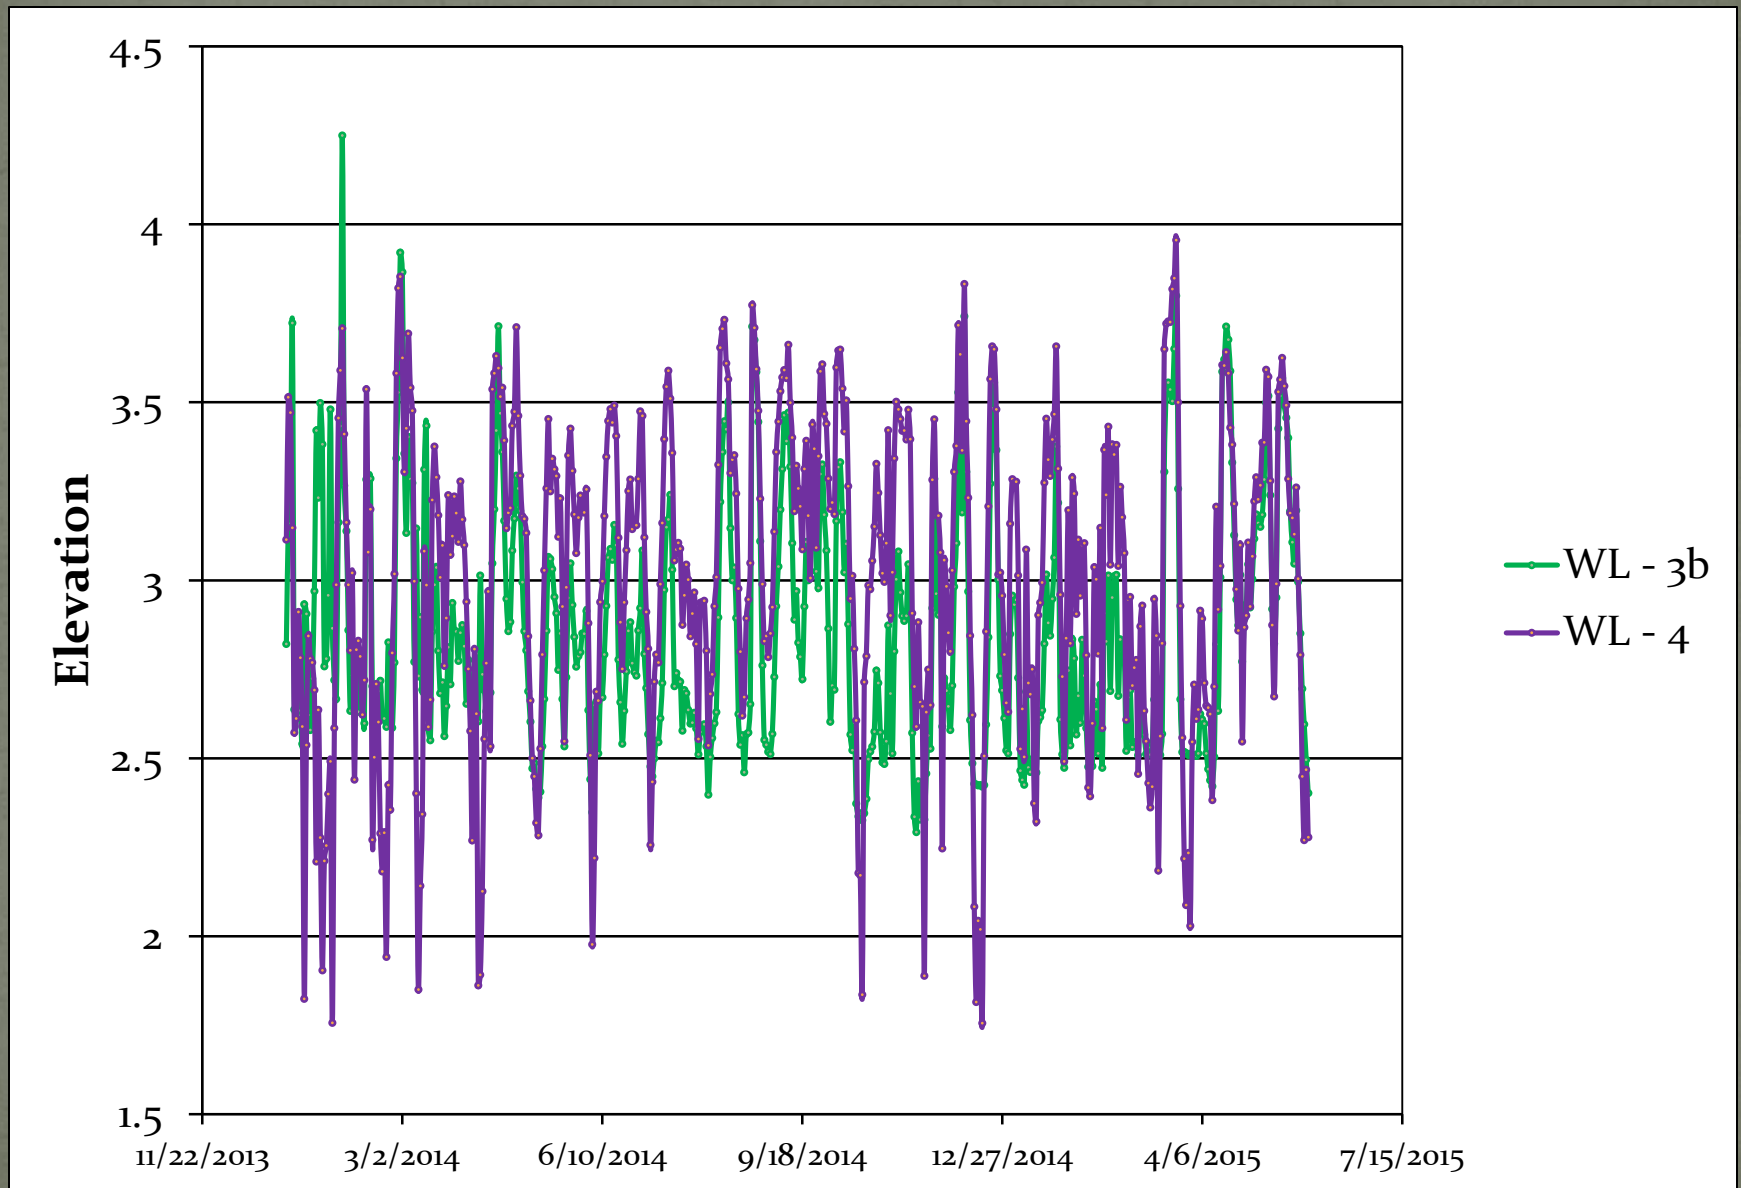
Fortson Pond & Small Marsh Daily Maxes

- How would culverts alter water levels in Fortson Pond?
 - Right now, water flows thru the north end every day at least once
- What would a culvert on the south end do to the water levels in Fortson Pond?
 - ???

- Fortson Pond is dominated by a decaying bloom of *Aphanothece stagnina* and Cabin Pond that has a live bloom of the same nature.
- This is correlated with very high nutrient levels, low tidal circulation, relatively low salinity, and indicators of fecal contamination at both sites.
- Structured observation does not reveal differences in the bird community across the study areas
- The pond areas studied lack conspicuous macroinverts
- The installation of a culvert at the south end of Fortson Pond connecting it to Small Marsh would transmit water into Fortson from the south 88% of days
