# **Feasibility Study to Examine Potential Hydrological and Biological Benefits from Restoring Flow of a Salt Marsh Creek at the Edisto Beach Causeway**

## **Final Project Completion Report**

**NOAA Grant Number: NA03NOS4630167**

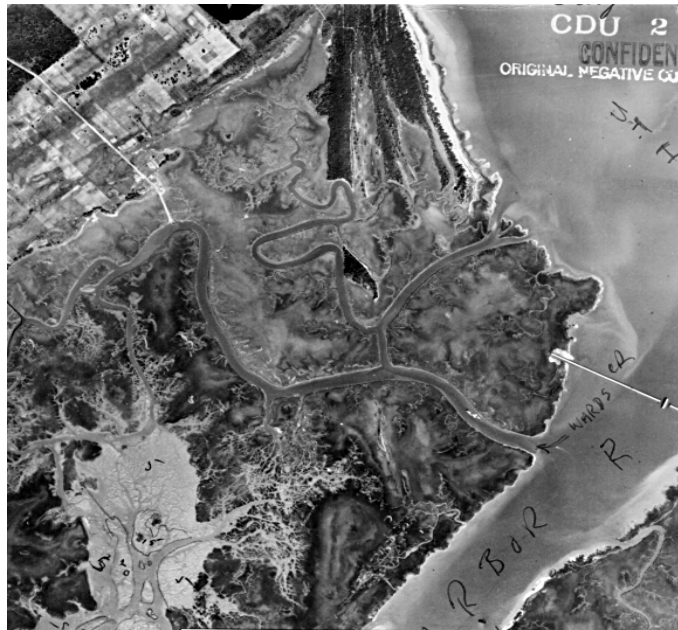
Fig. 1. Areal photograph near Harbor River prior to causeway construction.

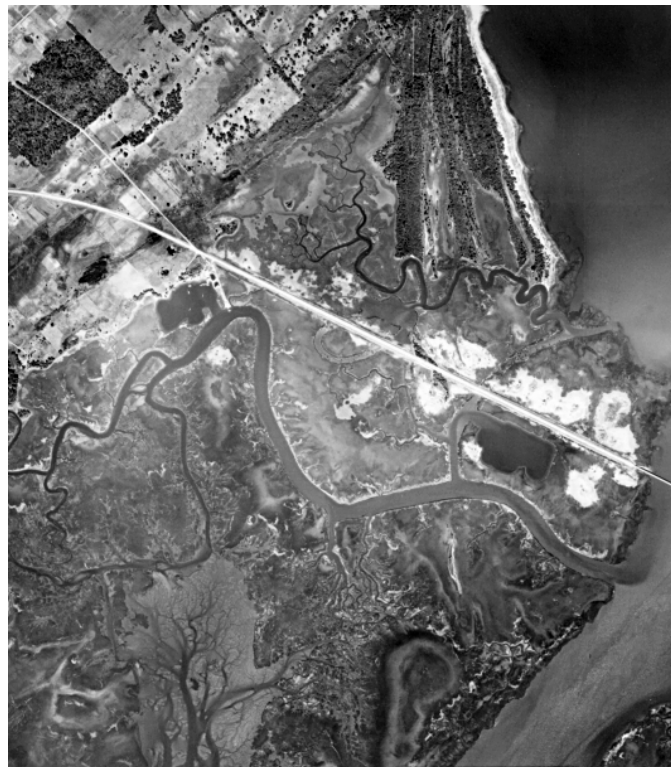
Fig. 2. Post causeway view of Harbor River Causeway. Note dredge spoil in the marsh and the cut off creeks.

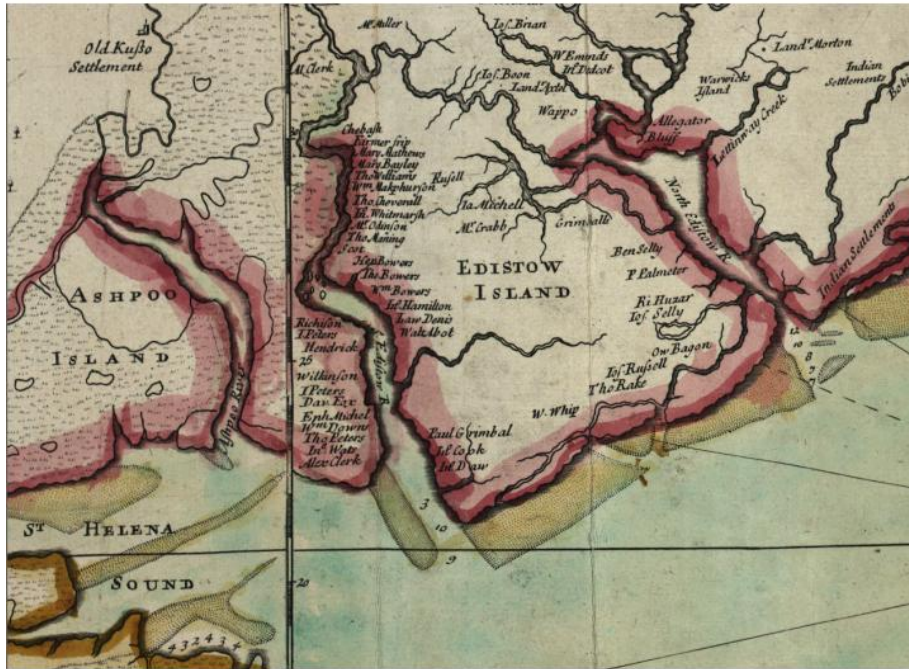
Figure 6. Map of Edisto Island region from approximately 1711, copied from holdings of the U.S. Library of Congress, 2007.

The earliest map, from around 1711, was geo-rectified using 6 points corresponding to creek inlets proximal to the study area, accurate to approximately 0.37 mi. The map from 1775 was rectified using similar points, with an accuracy of around 0.5 mi. The map from 1820, shown in Fig. 8, was rectified with an accuracy of around 0.12 mi. The map from 1862 was of higher quality and more accurately rectified with an accuracy of around 20 m (66 ft). The 1919 topographic map was rectified using 15 points of reference, including creek inlets and roadways, with an accuracy of around 20 m (approximately 66 ft). The USDA images were much easier to rectify because they were photographs, rather than human interpretation. Only 4 to 6 points of reference were used for rectifying these images. Accuracies were better than 5 m (approximately 16 ft)

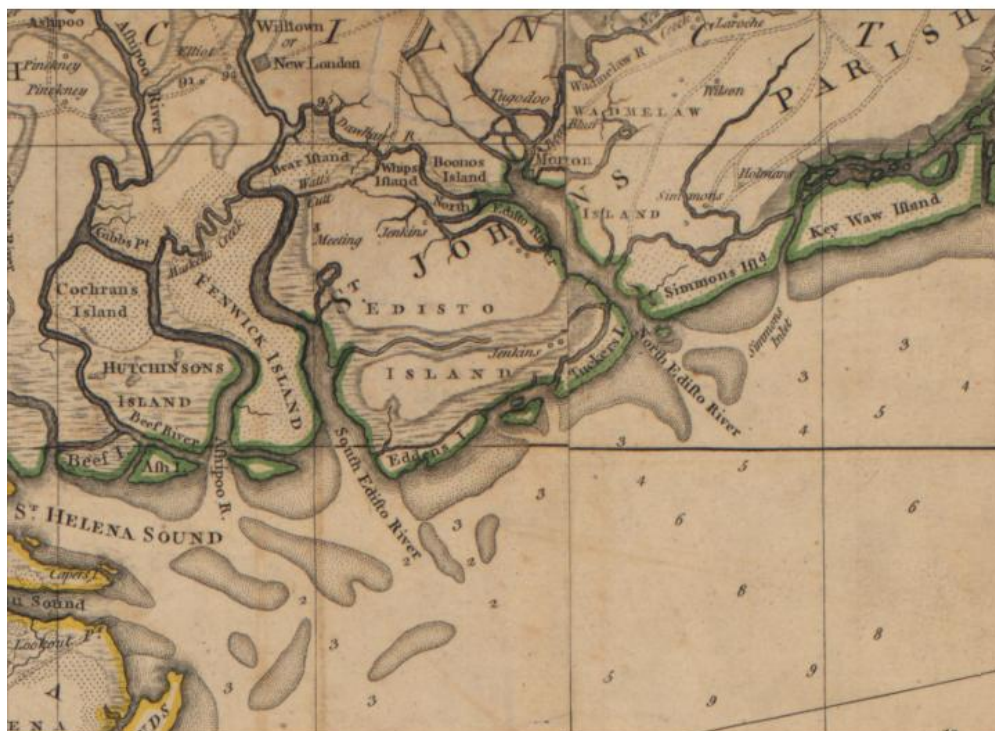
Fig. 7. Map of Edisto Island region from approximately 1775, copied from holdings of the U.S. Library of Congress, 2007.

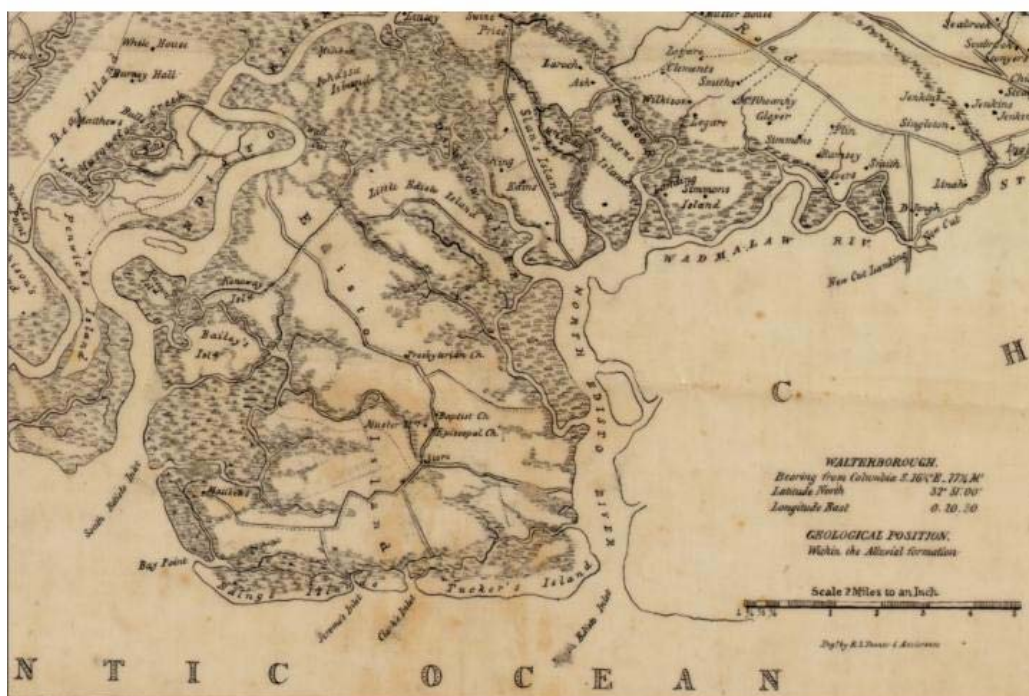
Fig. 8. Map of Edisto Island region produced in 1820, improved for Robert Mill's Atlas of 1825, copied from holdings of the U.S. Library of Congress, 2007.

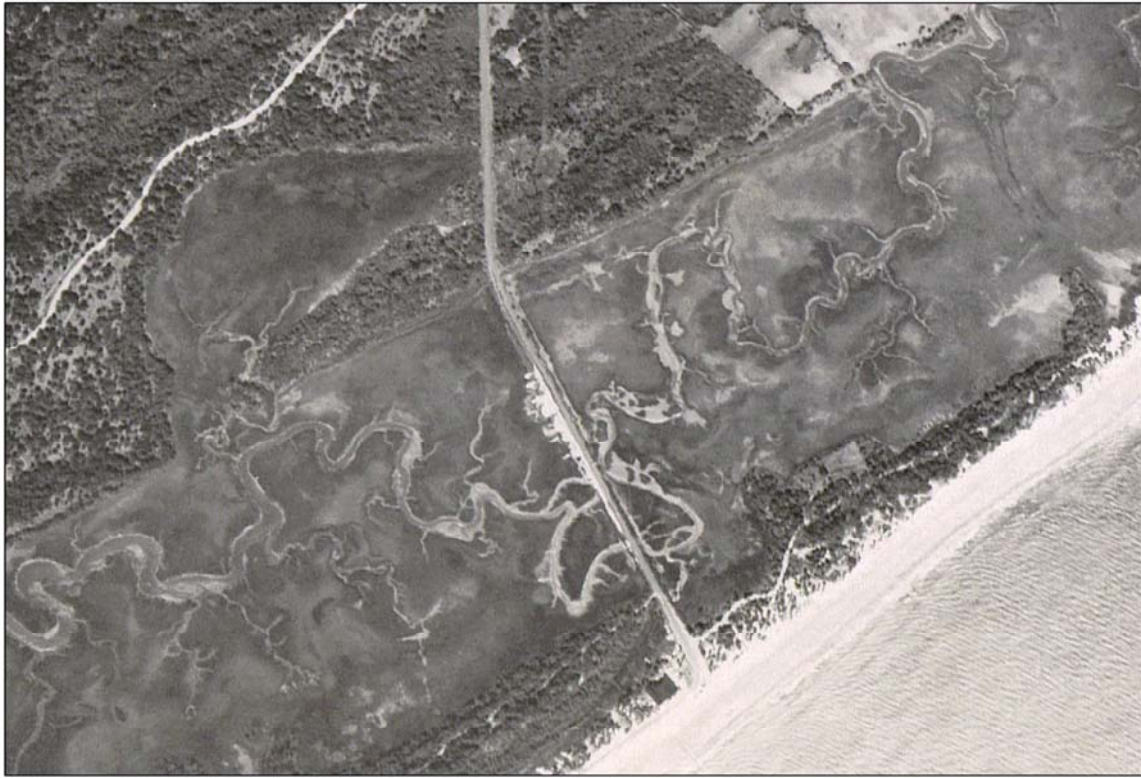
Fig. 9. The March 11, 1949 aerial photograph shows the new asphalt causeway, after being hit by an unnamed hurricane 9 years prior. Also shows how the system appeared with East and West Scott Creeks united, copied from the University of South Carolina's Map Library, 2006.

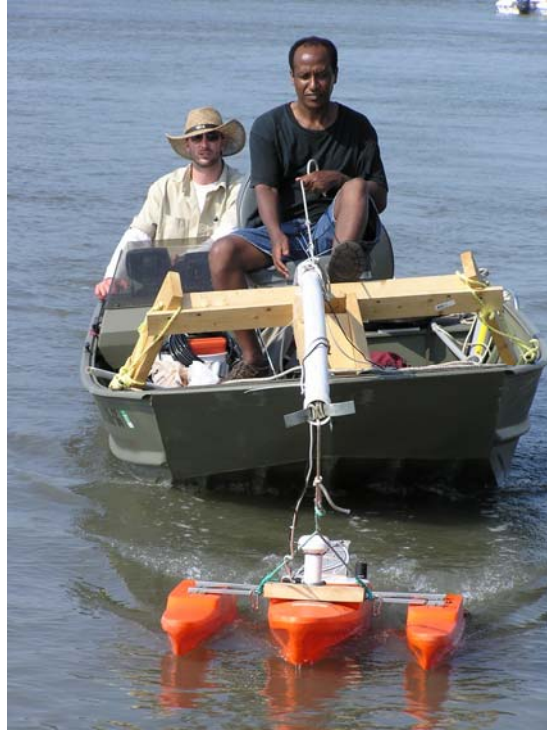
Fig. 19. Forward-push mount and operation for Riverboat trimaran for use with ADCP, equipped with GPS and sonar.

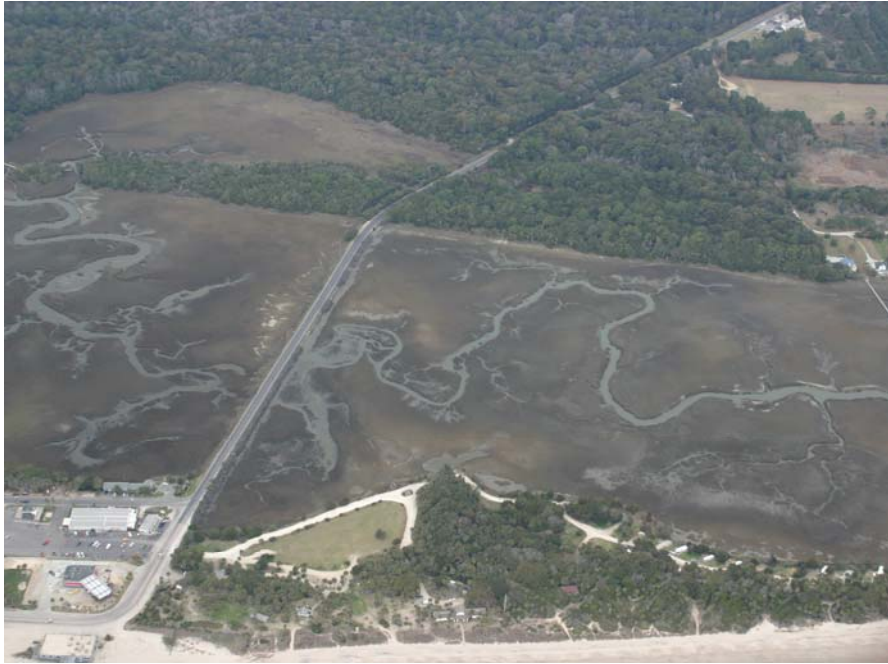
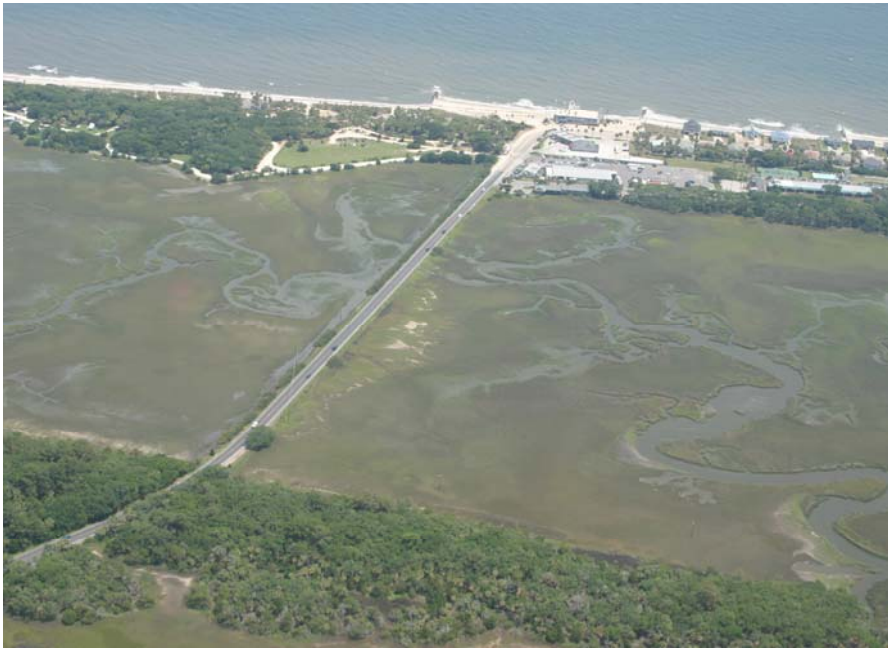
Fig. 42. Oblique aerial photographs taken at an elevation of 1500 ft in (A) March and (B) June of 2004.

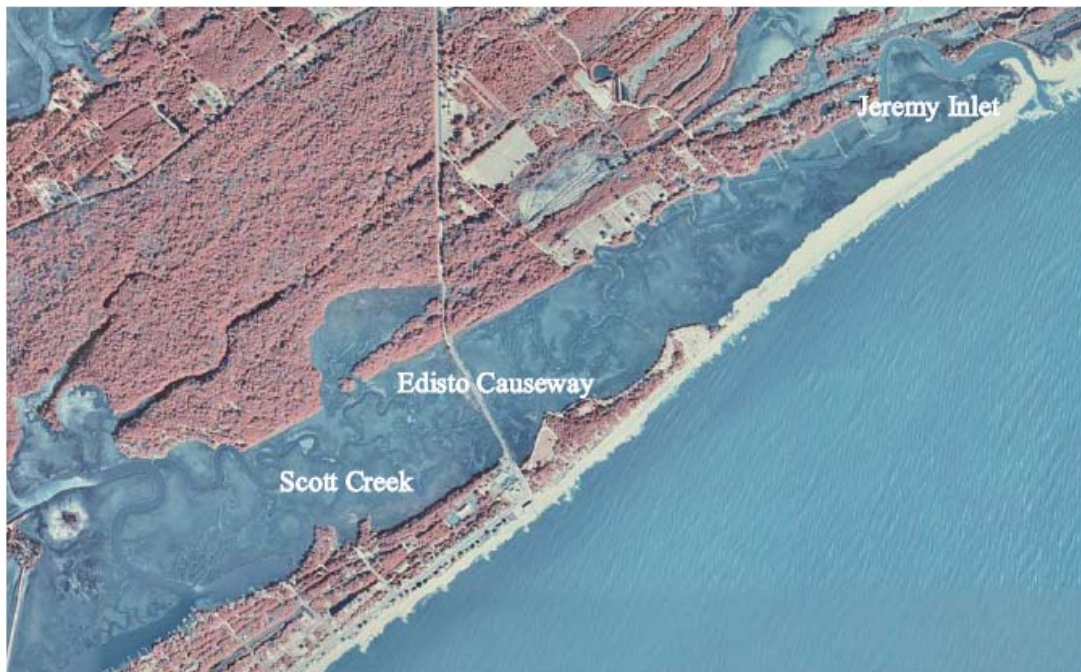
Fig. 55. Geological study area.

An expanse of salt marsh divides a Holocene barrier complex, known as Edisto Beach, from Edisto Island, a Pleistocene age beach/barrier complex (Figs. 55 and 56). During modern times, a mesotidal influx of ocean water has flooded this salt marsh twice daily. Periodic tidal ebb and flood produces a bi-directional flow; therefore, transport energy from this tidally-influenced flow changes over time as a sinusoidal function. In response, deposition of sediment is fractionated in both flood and ebb directions along the channels and into the salt marsh. Sediment sources include the erosion of banks and channels, and the entrainment of beach sediments. Sinuous channels, formed by this tidally induced flow, transport sediment down gradient for eventual deposition. This particular salt marsh is fed from two directions. Scott Creek, branching from the larger ocean-fed Big Bay Creek, provides flow from the southwest. Jeremy Inlet, found on the northern end of a wash-over beach, provides influx from the northeast. A causeway has effectively isolated this once-connected marsh into two separate systems.
